## Vehicle Tool Compartment Explosion

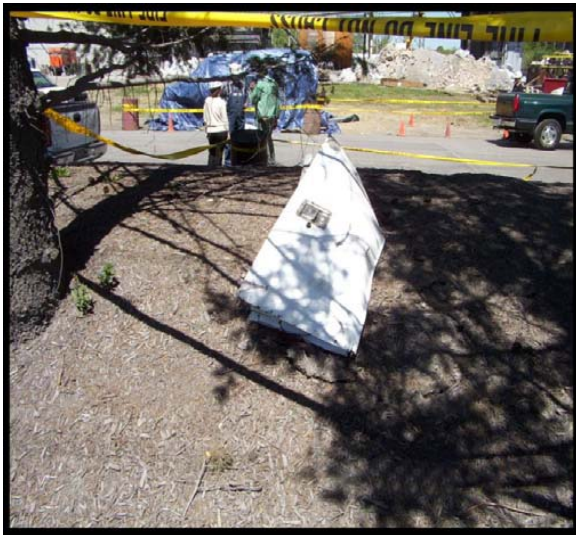
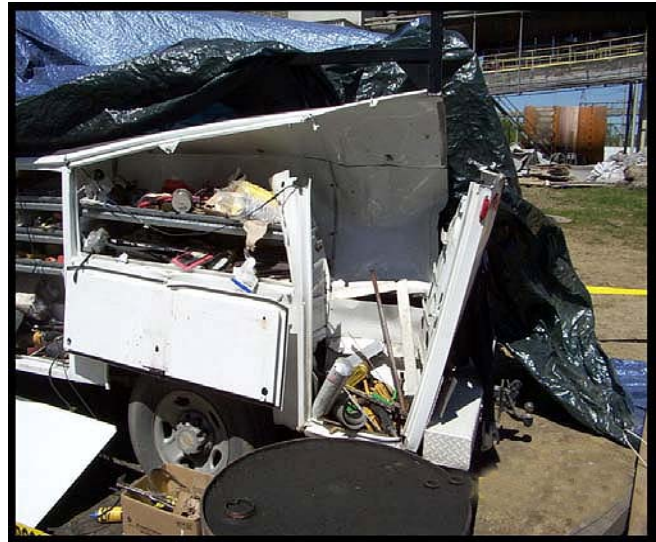
On Saturday, May 7, 2005 an accident occurred involving a contractor at a cement operation. Two employees had just arrived in a service truck. The doors to the tool compartments locked and unlocked by using a 12 volt, wireless remote key fob. When one of the employees pushed the button on the fob, an explosion occurred. It sent one of the doors approximately 40 feet through the air. The employee closest to the truck suffered a broken finger as he was reaching into another door when the explosion occurred. A 20 lb. cylinder of acetylene was stored inside the utility body. The cylinder was full when placed in the body 15 days prior to the accident. The cylinder valve did not have a protective cover. Tests showed that the valve would leak if slightly bumped. The cylinder was found to be  $\frac{3}{4}$  full after the accident. The company that built the utility body knew of no previous accidents but will equip all body doors with stickers to warn against storing flammable materials inside the compartment.

- Do not store flammable gases or liquids in any vehicle with automatic or wireless door locks.
- Leak test all flammable containers and cylinders.
- All combustible gas cylinders must have protective valve covers when transported or stored.
- If a vehicle is equipped with remote keyless entry, signs prohibiting storage of flammables should be provided.
- Develop a plan that addresses the potential hazard, proper flammable storage, and procedures to prevent a similar occurrence.
